**Flood Control Project Maintenance  
Levee Inspections**

**Fall 2013 Levee Maintenance Deficiency Summary Report**

**San Joaquin River Basin**

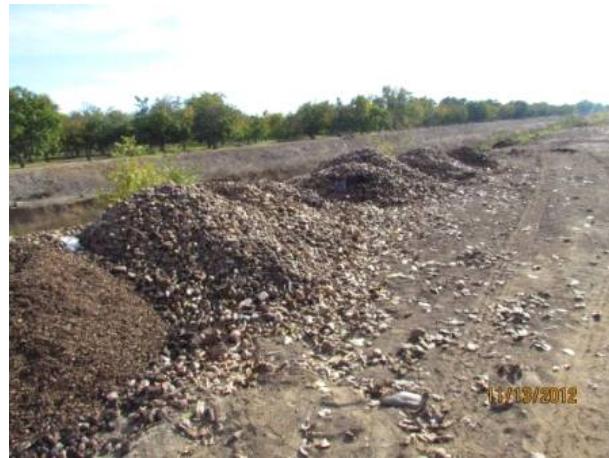
Levee Mile Report Line	51
Start Levee Mile	5.60
End Levee Mile	5.65
Location	Water Side
Category	Earthen Levee
Item	Encroachments
In addition to the walnut piles, there were rocks and debris were found at the landside shoulder of the levee looking downstream.	pkazi_f_20131001_376.jpg

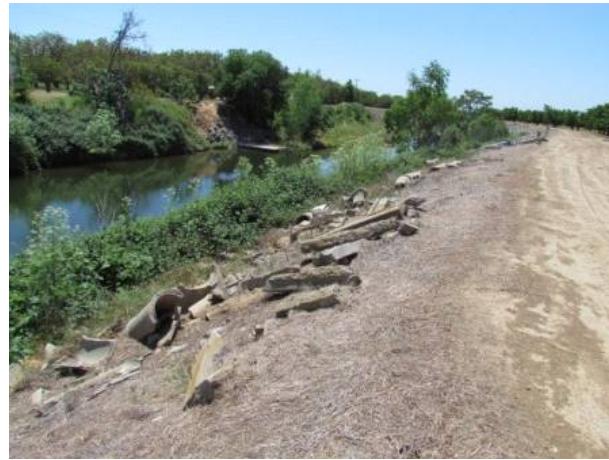
Levee Mile Report Line	55
Start Levee Mile	5.76
End Levee Mile	5.86
Location	Water Side
Category	Earthen Levee
Item	Encroachments
Broken concrete pipes and other debris was found on the waterside of the levee. The picture was taken from the crown looking downstream.	pkazi_f_20131001_268.jpg

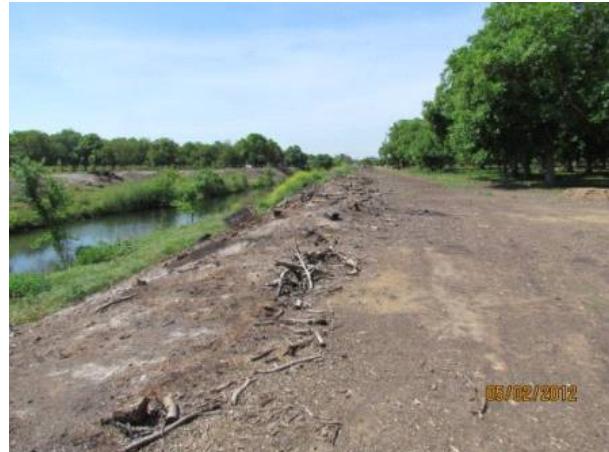
Levee Mile Report Line	55
Start Levee Mile	5.76
End Levee Mile	5.86
Location	Water Side
Category	Earthen Levee
Item	Encroachments
Debris was still on the waterside of the levee looking downstream. This picture was taken during Spring 2012 inspection.	
pkazi_f_20131001_269.jpg

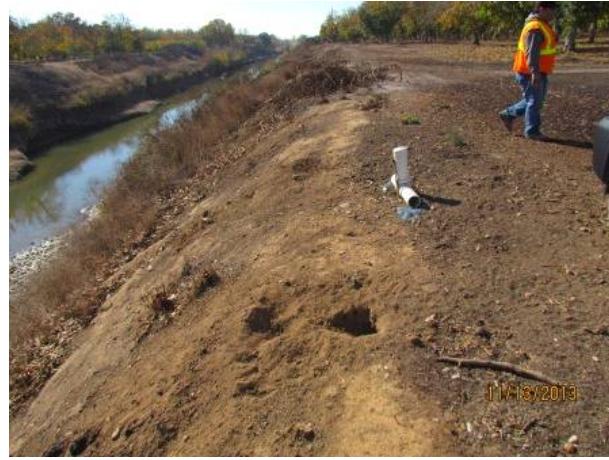
Levee Mile Report Line	56
Start Levee Mile	5.77
End Levee Mile	5.77
Location	Water Side
Category	Earthen Levee
Item	Animal Control
Updated picture of the animal holes on the waterside of the levee looking downstream.	
pkazi_f_20131119_054.JPG

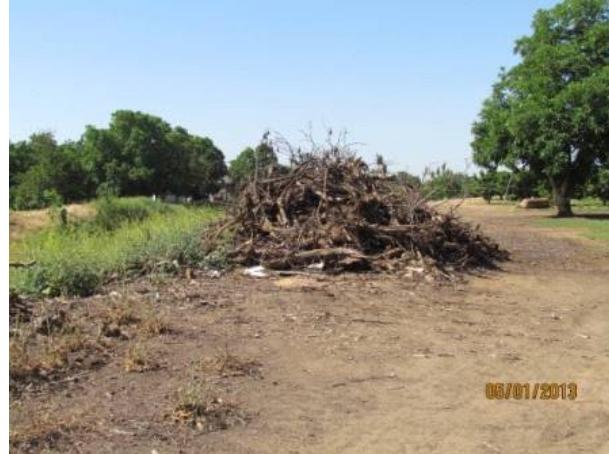
Levee Mile Report Line	57
Start Levee Mile	5.86
End Levee Mile	5.86
Location	Water Side
Category	Earthen Levee
Item	Encroachments
Prunings were found on the waterside slope of the levee looking downstream.	
pkazi_f_20131001_274.JPG

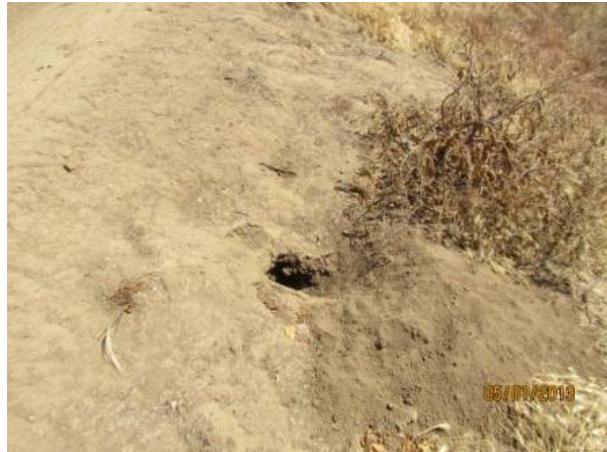
Levee Mile Report Line	62
Start Levee Mile	6.12
End Levee Mile	6.12
Location	Water Side
Category	Earthen Levee
Item	Animal Control
An animal hole was found on the waterside slope of the levee looking upstream.	
pkazi_f_20131001_282.JPG

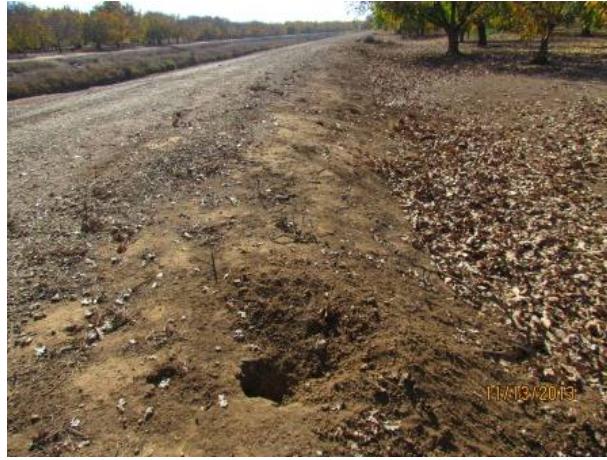
Levee Mile Report Line	66
Start Levee Mile	6.57
End Levee Mile	6.57
Location	Land Side
Category	Earthen Levee
Item	Animal Control
Rodent holes were found on the landside of the levee looking downstream.	
pkazi_f_20131119_056.JPG

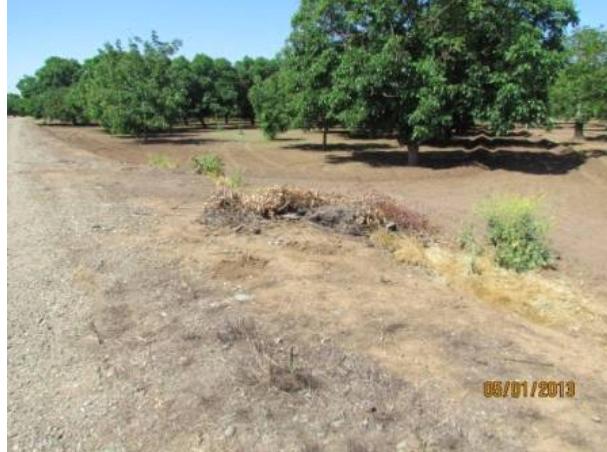
Levee Mile Report Line	67
Start Levee Mile	6.59
End Levee Mile	6.59
Location	Land Side
Category	Earthen Levee
Item	Encroachments
Prunings were found on the landside of the levee looking downstream.	
pkazi_f_20131001_328.JPG

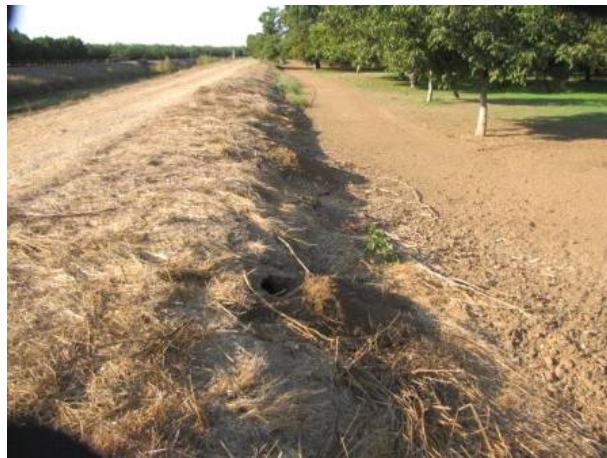
Levee Mile Report Line	68
Start Levee Mile	6.61
End Levee Mile	6.61
Location	Land Side
Category	Earthen Levee
Item	Animal Control
View of rodent activity in the landward slope looking downstream.	
pkazi_f_20131001_321.jpg

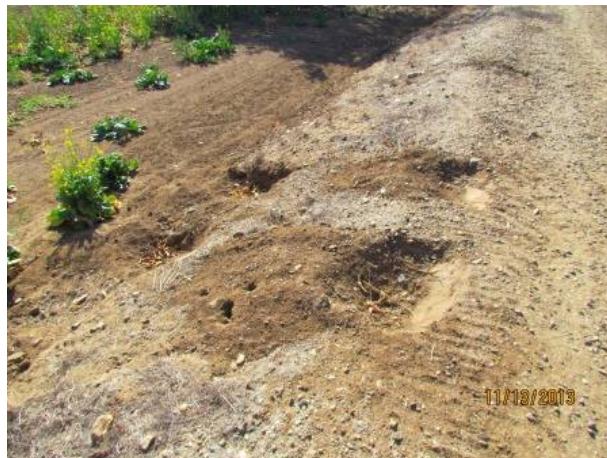
Levee Mile Report Line	70
Start Levee Mile	6.81
End Levee Mile	6.81
Location	Water Side
Category	Earthen Levee
Item	Slope Stability
Slope instability caused by vehicular traffic on the waterside slope of the levee looking downstream.	
pkazi_f_20131119_057.JPG

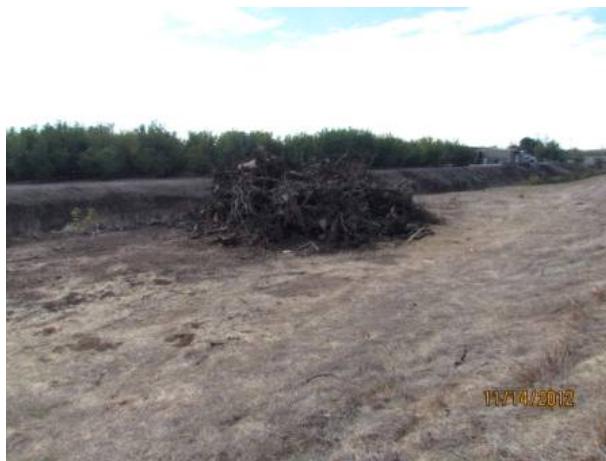
pkazi_f_20131001_322.jpg

Levee Mile Report Line	72
Start Levee Mile	6.89
End Levee Mile	6.89
Location	Water Side
Category	Earthen Levee
Item	Encroachments
Prunings were found on the waterside shoulder of the levee looking downstream.

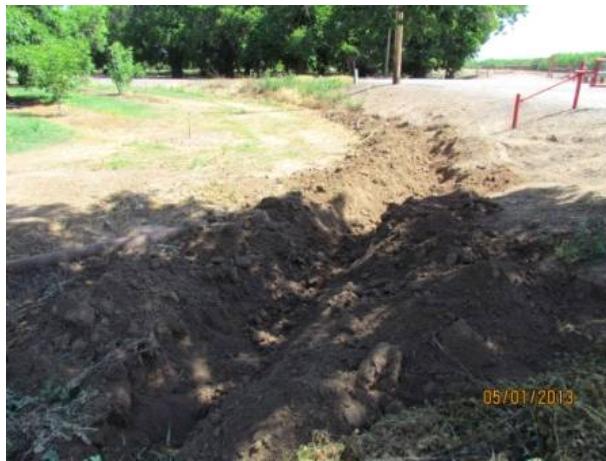
pkazi_f_20131001_293.JPG

Levee Mile Report Line	73
Start Levee Mile	7.09
End Levee Mile	7.09
Location	Land Side
Category	Earthen Levee
Item	Encroachments
An agricultural ditch was found on the landside toe of the levee looking upstream.

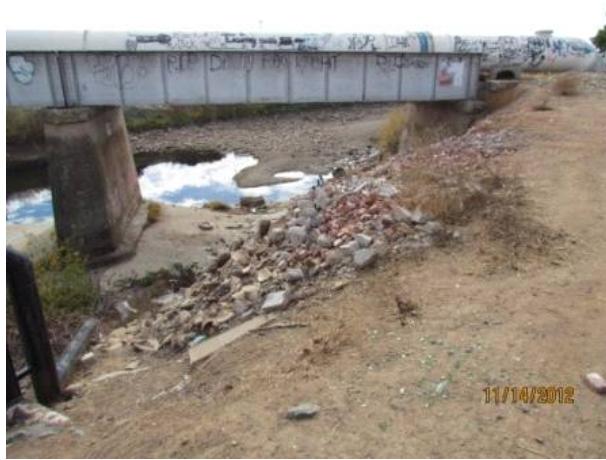
pkazi_f_20131001_330.jpg

Levee Mile Report Line	76
Start Levee Mile	7.36
End Levee Mile	7.36
Location	Water Side
Category	Earthen Levee
Item	Encroachments
Debris was found on the waterside slope of the levee looking downstream.

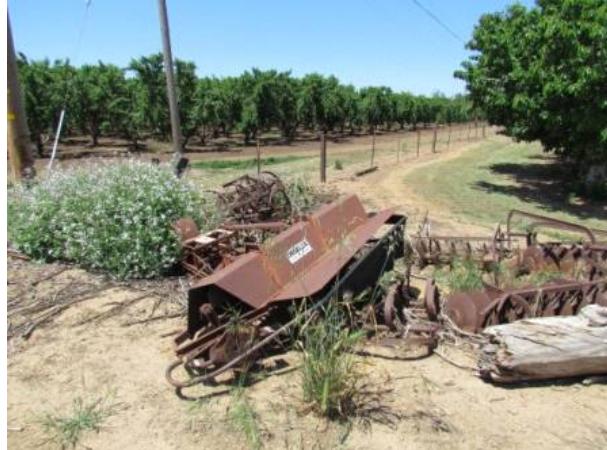
Levee Mile Report Line	77
Start Levee Mile	7.98
End Levee Mile	7.98
Location	Land Side
Category	Earthen Levee
Item	Encroachments
Equipment was left by the farmers on the landside of the levee. The picture was taken from crown looking toward the landside of the levee.	
pkazi_f_20131001_353.jpg

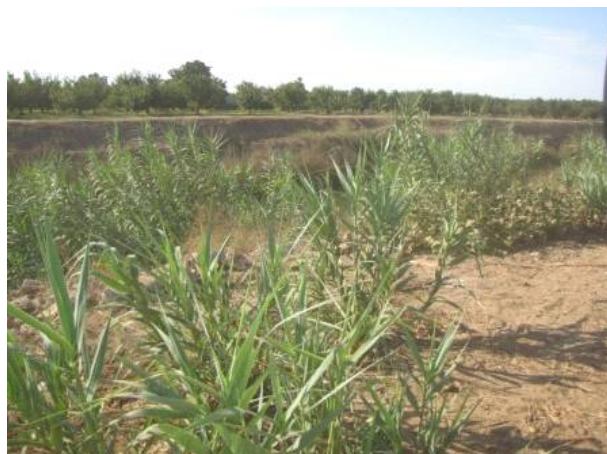
Levee Mile Report Line	79
Start Levee Mile	8.06
End Levee Mile	8.06
Location	Water Side
Category	Earthen Levee
Item	Vegetation
View of arundo on the waterward shoulder and slope blocking visibility looking downstream.	
pkazi_f_20131001_331.jpg

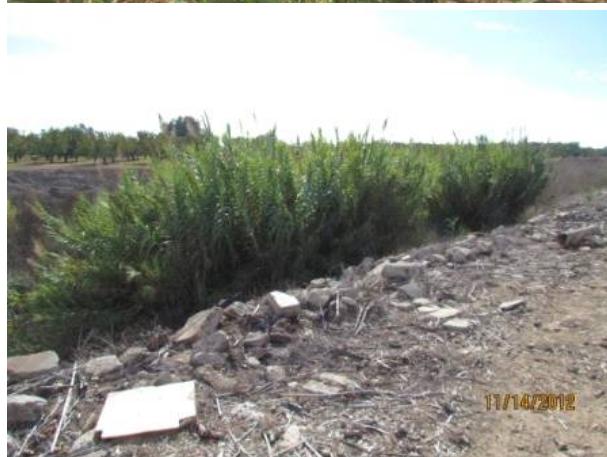
Levee Mile Report Line	79
Start Levee Mile	8.06
End Levee Mile	8.06
Location	Water Side
Category	Earthen Levee
Item	Vegetation
Updated picture of the Arundo on the waterside slope of the levee looking downstream.	
pkazi_f_20131001_332.jpg

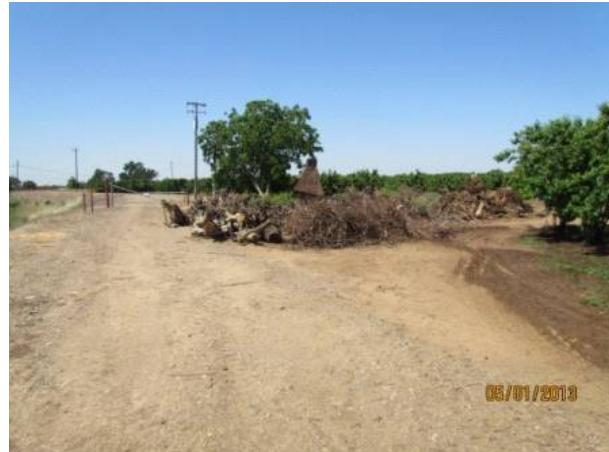
Levee Mile Report Line	80
Start Levee Mile	8.24
End Levee Mile	8.24
Location	Land Side
Category	Earthen Levee
Item	Encroachments
Prunings were found on the landside of the levee looking downstream.	
pkazi_f_20131001_275.JPG

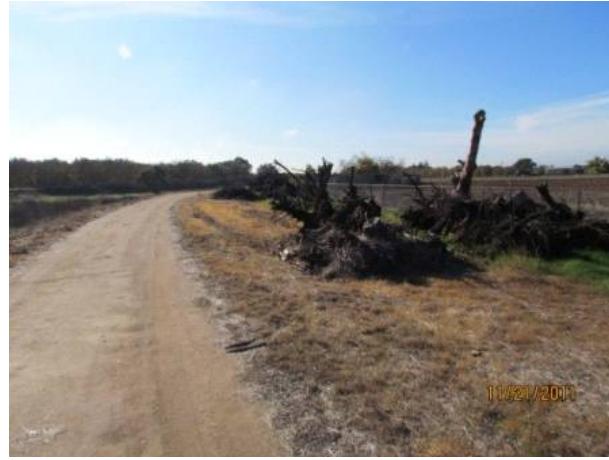
Levee Mile Report Line	84
Start Levee Mile	8.47
End Levee Mile	8.50
Location	Land Side
Category	Earthen Levee
Item	Encroachments
Prunings were found on the landside of the levee looking downstream.	
pkazi_f_20131001_391.jpg

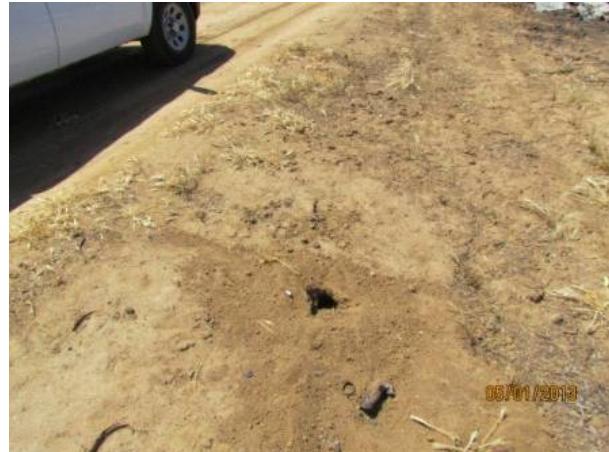
Levee Mile Report Line	85
Start Levee Mile	8.49
End Levee Mile	8.49
Location	Land Side
Category	Earthen Levee
Item	Animal Control
An animal hole was found on the landside slope of the levee looking downstream.	
pkazi_f_20131001_300.JPG

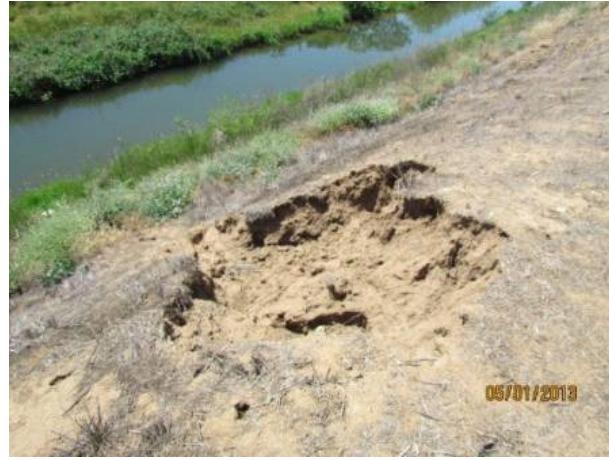
Levee Mile Report Line	87
Start Levee Mile	8.61
End Levee Mile	8.61
Location	Water Side
Category	Earthen Levee
Item	Slope Stability
A slope Instability was found on the waterside slope of the levee looking downstream.	
pkazi_f_20131001_303.JPG

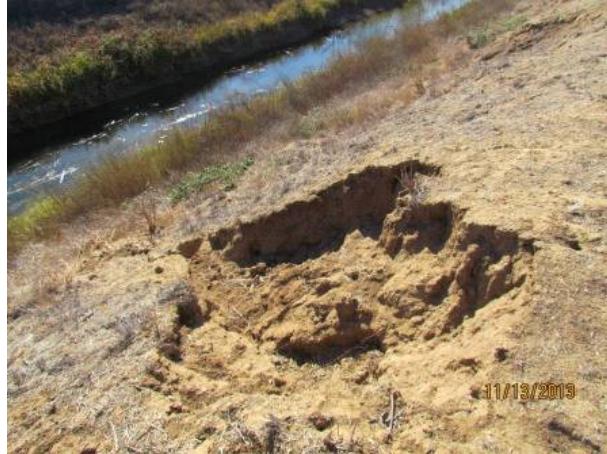
Levee Mile Report Line	87
Start Levee Mile	8.61
End Levee Mile	8.61
Location	Water Side
Category	Earthen Levee
Item	Slope Stability
Updated picture of the slope instability on the waterside of the levee looking downstream during fall 2013 inspection.	
pkazi_f_20131119_058.JPG

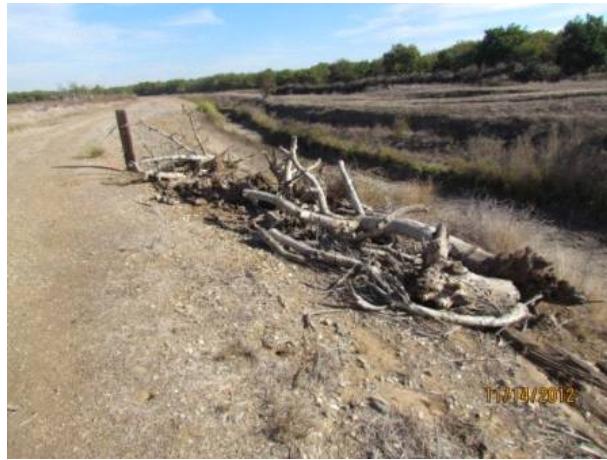
Levee Mile Report Line	89
Start Levee Mile	8.66
End Levee Mile	8.66
Location	Water Side
Category	Earthen Levee
Item	Encroachments
Prunings were found on the waterside slope of the levee looking upstream.	
pkazi_f_20131001_370.jpg

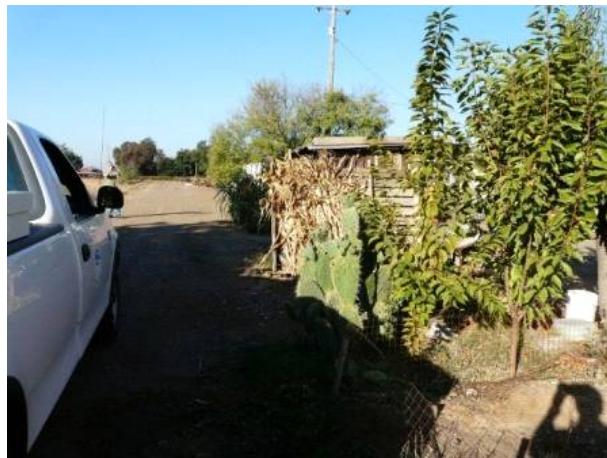
Levee Mile Report Line	91
Start Levee Mile	8.72
End Levee Mile	8.72
Location	Land Side
Category	Earthen Levee
Item	Encroachments
Building, fence and landscaping immediately adjacent to the access road at LM 8.72.	
pkazi_f_20131001_318.JPG

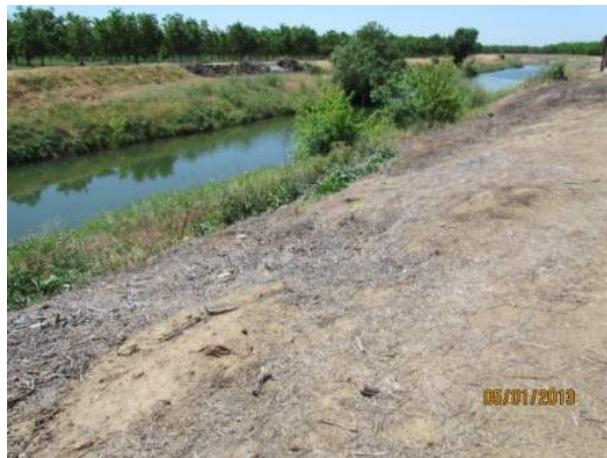
Levee Mile Report Line	93
Start Levee Mile	9.59
End Levee Mile	9.59
Location	Water Side
Category	Earthen Levee
Item	Slope Stability
A slope Instability was found on the waterside slope of the levee looking downstream.	
pkazi_f_20131001_345.JPG

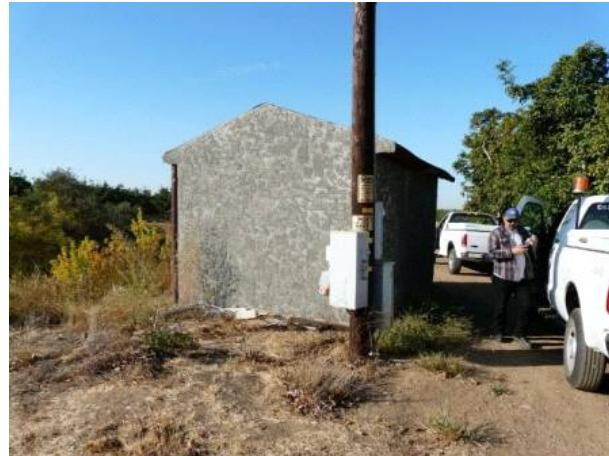
Levee Mile Report Line	94
Start Levee Mile	9.63
End Levee Mile	9.63
Location	Water Side
Category	Earthen Levee
Item	Encroachments
Building located at LM 9.63 on waterside of access road. This building appears to be recently constructed and does not currently contain anything.	
pkazi_f_20131001_280.JPG

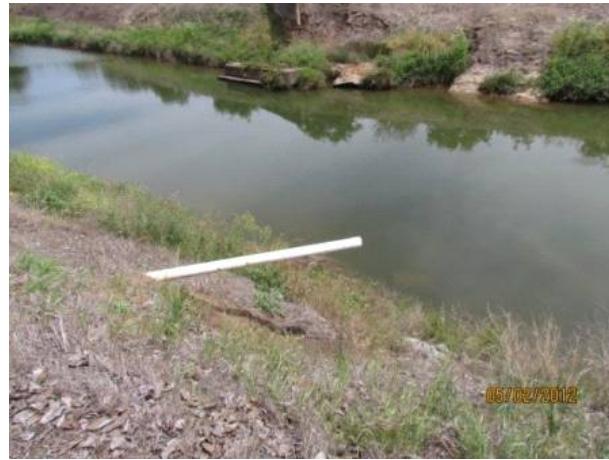
Levee Mile Report Line	95
Start Levee Mile	9.76
End Levee Mile	9.76
Location	Water Side
Category	Earthen Levee
Item	Encroachments
A perforated PVC pipe was found on the waterside slope of the levee looking upstream.	
pkazi_f_20131001_351.jpg

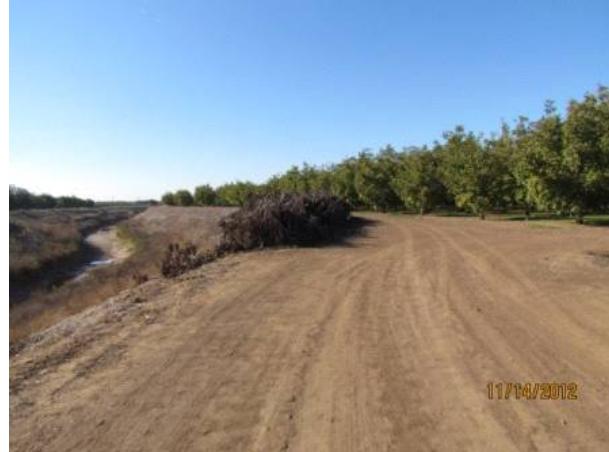
Levee Mile Report Line	96
Start Levee Mile	10.01
End Levee Mile	10.01
Location	Water Side
Category	Earthen Levee
Item	Encroachments
Prunings were found on the waterside shoulder of the levee looking downstream.	
pkazi_f_20131001_356.jpg

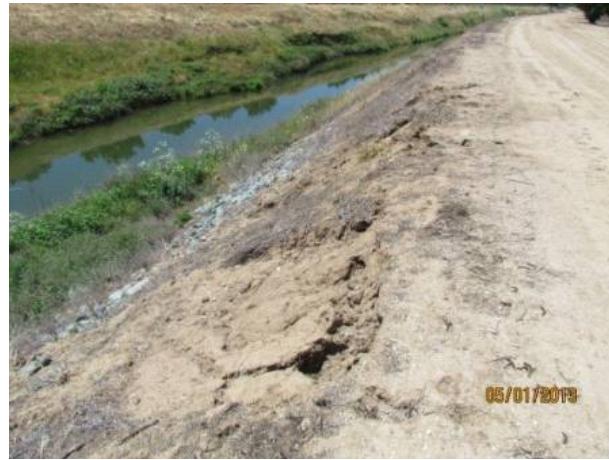
Levee Mile Report Line	98
Start Levee Mile	10.11
End Levee Mile	10.11
Location	Water Side
Category	Earthen Levee
Item	Slope Stability
Slope instability was found on the waterside slope of the levee looking downstream.	
pkazi_f_20131001_306.JPG

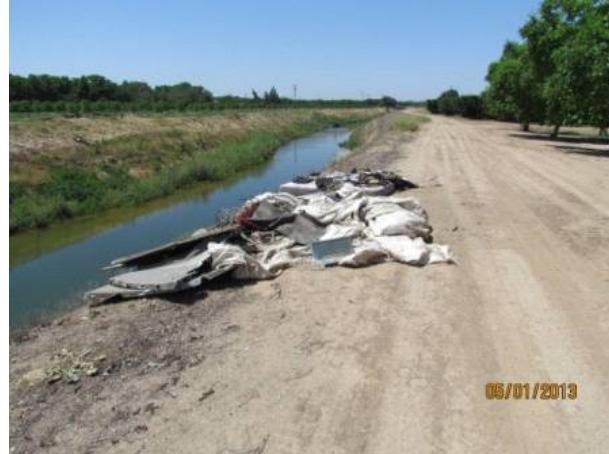
Levee Mile Report Line	99
Start Levee Mile	10.19
End Levee Mile	10.19
Location	Water Side
Category	Earthen Levee
Item	Encroachments
Debris was found on the waterside slope of the levee looking downstream.	
pkazi_f_20131001_307.JPG

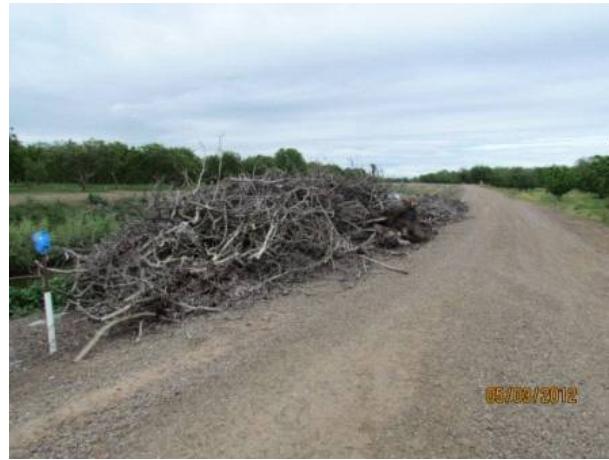
Levee Mile Report Line	101
Start Levee Mile	10.62
End Levee Mile	10.62
Location	Water Side
Category	Earthen Levee
Item	Encroachments
Prunings were found on the waterside of the levee looking downstream.	
pkazi_f_20131001_313.jpg

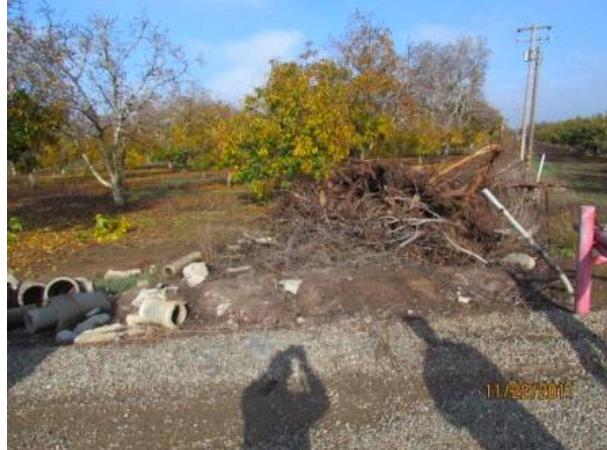
Levee Mile Report Line	102
Start Levee Mile	10.76
End Levee Mile	10.76
Location	Land Side
Category	Earthen Levee
Item	Encroachments
Prunings were found on the landside of the levee looking downstream.	
<i>pkazi_f_20131001_378.jpg</i>

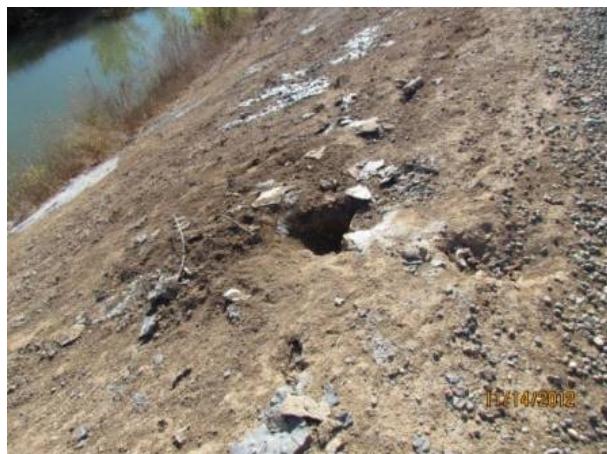
Levee Mile Report Line	104
Start Levee Mile	11.05
End Levee Mile	11.05
Location	Water Side
Category	Earthen Levee
Item	Animal Control
An animal hole was found on the waterside slope of the levee looking downstream.	
<i>pkazi_f_20131001_354.jpg</i>

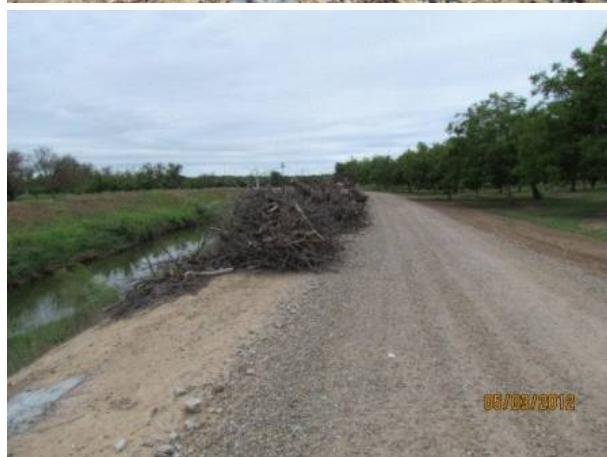
Levee Mile Report Line	105
Start Levee Mile	11.06
End Levee Mile	11.06
Location	Water Side
Category	Earthen Levee
Item	Encroachments
Prunings were found on the waterside of the levee looking downstream.	
<i>pkazi_f_20131001_352.jpg</i>

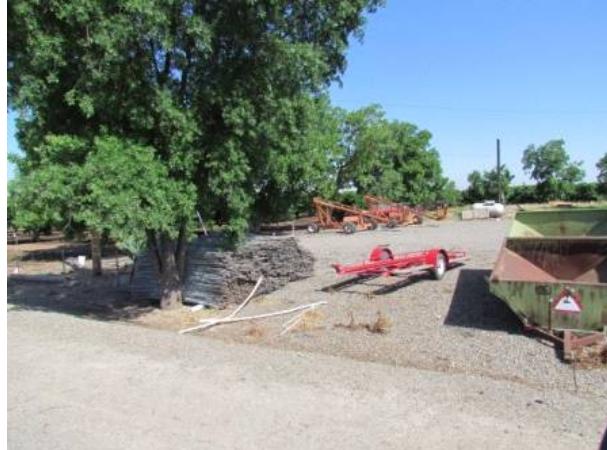
Levee Mile Report Line	106
Start Levee Mile	11.58
End Levee Mile	11.58
Location	Land Side
Category	Earthen Levee
Item	Encroachments
Equipment on the landside of the levee. The picture was taken from the crown looking downstream.	
pkazi_f_20131001_357.jpg

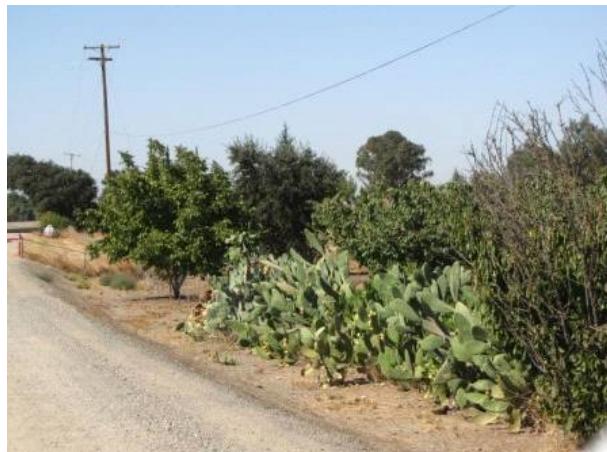
Levee Mile Report Line	107
Start Levee Mile	11.61
End Levee Mile	11.61
Location	Land Side
Category	Earthen Levee
Item	Vegetation
View of cactus within 10 feet of the landward toe blocking visibility and access.	
pkazi_f_20131001_336.jpg

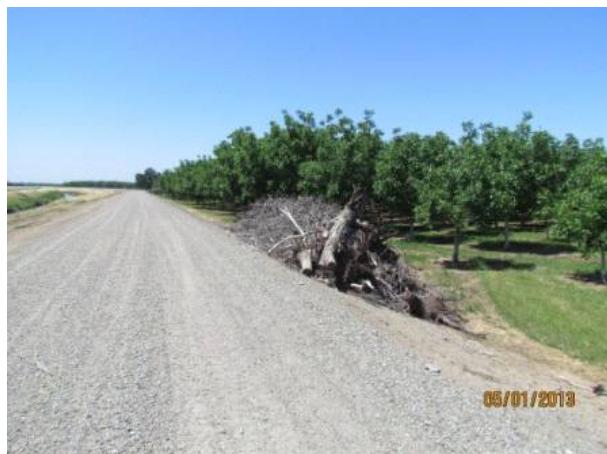
Levee Mile Report Line	110
Start Levee Mile	12.08
End Levee Mile	12.08
Location	Land Side
Category	Earthen Levee
Item	Encroachments
Prunings were found on the landside slope of the levee looking downstream.	
pkazi_f_20131001_371.JPG

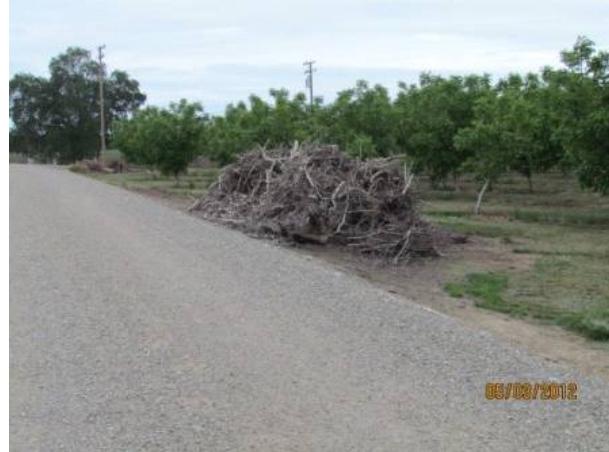
Levee Mile Report Line	111
Start Levee Mile	12.21
End Levee Mile	12.21
Location	Land Side
Category	Earthen Levee
Item	Encroachments
Prunings were found on the landside of the levee looking downstream.	
<i>pkazi_f_20131001_288.jpg</i>

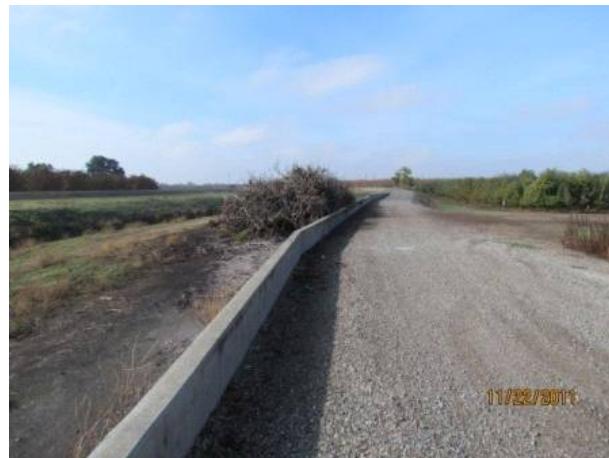
Levee Mile Report Line	112
Start Levee Mile	12.82
End Levee Mile	12.82
Location	Water Side
Category	Earthen Levee
Item	Encroachments
Prunings were found on the waterside of the levee looking downstream.	
<i>pkazi_f_20131001_289.jpg</i>

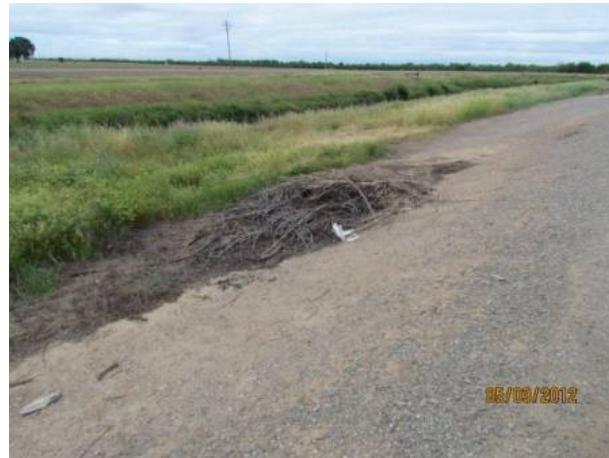
Levee Mile Report Line	113
Start Levee Mile	12.99
End Levee Mile	12.99
Location	Water Side
Category	Earthen Levee
Item	Encroachments
Prunings were found on the waterside of the levee looking downstream.	
<i>pkazi_f_20131001_392.jpg</i>

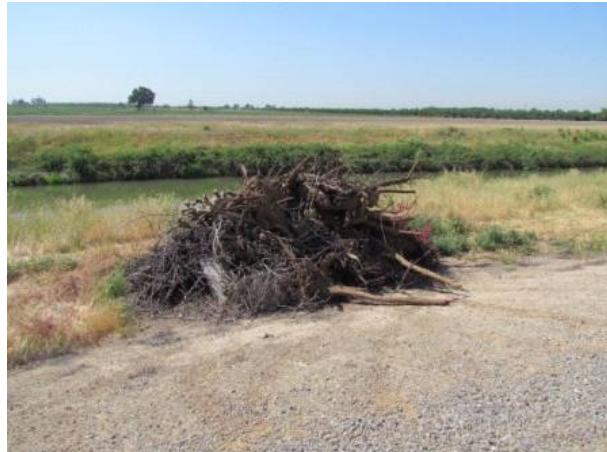
Levee Mile Report Line	114
Start Levee Mile	13.08
End Levee Mile	13.08
Location	Water Side
Category	Earthen Levee
Item	Encroachments
Prunning on the waterside of the levee looking downstream.	pkazi_f_20131001_358.jpg

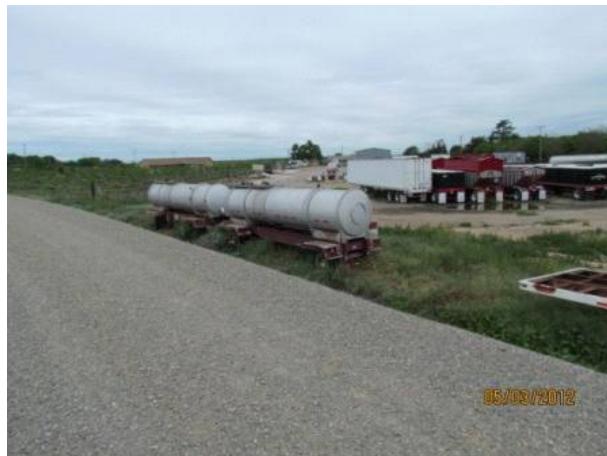
Levee Mile Report Line	116
Start Levee Mile	13.25
End Levee Mile	13.25
Location	Land Side
Category	Earthen Levee
Item	Encroachments
Equipment was found on the landside toe of the levee looking downstream.	pkazi_f_20131001_338.jpg

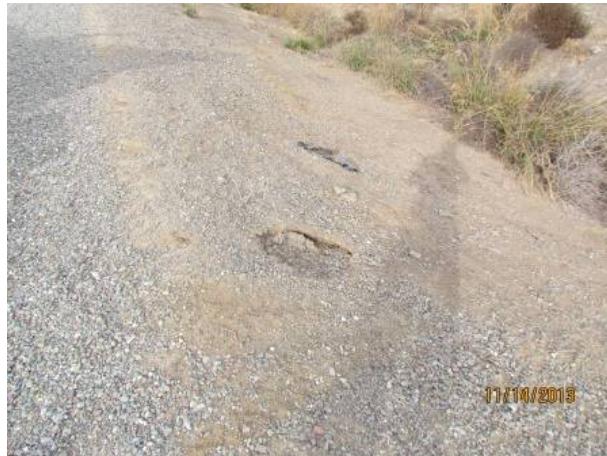
Levee Mile Report Line	117
Start Levee Mile	13.26
End Levee Mile	13.26
Location	Land Side
Category	Earthen Levee
Item	Animal Control
Rodent holes were found on the landside of the levee looking downstream.	pkazi_f_20131119_061.JPG

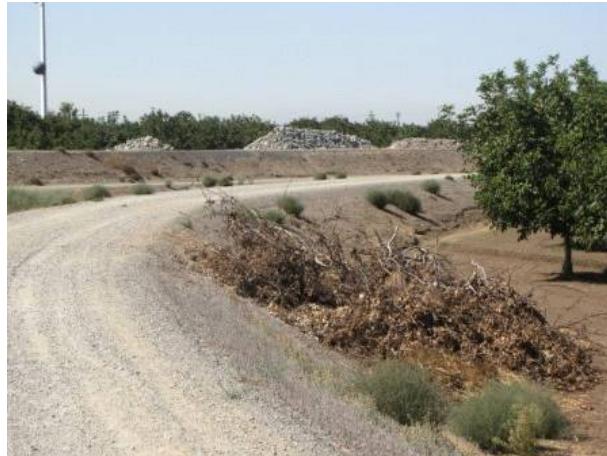
Levee Mile Report Line	118
Start Levee Mile	13.58
End Levee Mile	13.58
Location	Land Side
Category	Earthen Levee
Item	Encroachments
View of a prunings pile on the landward slope looking downstream. The resident stated it would be moved in a few weeks.	
pkazi_f_20131001_341.jpg

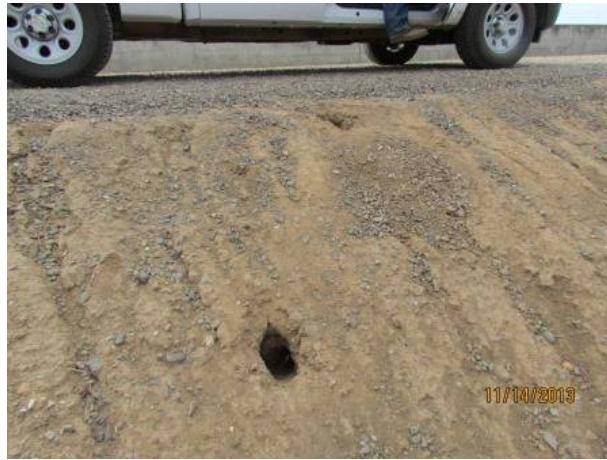
Levee Mile Report Line	121
Start Levee Mile	15.71
End Levee Mile	15.71
Location	Land Side
Category	Earthen Levee
Item	Animal Control
Animal holes were found on the landside slope of the levee looking downstream.	
pkazi_f_20131119_063.JPG

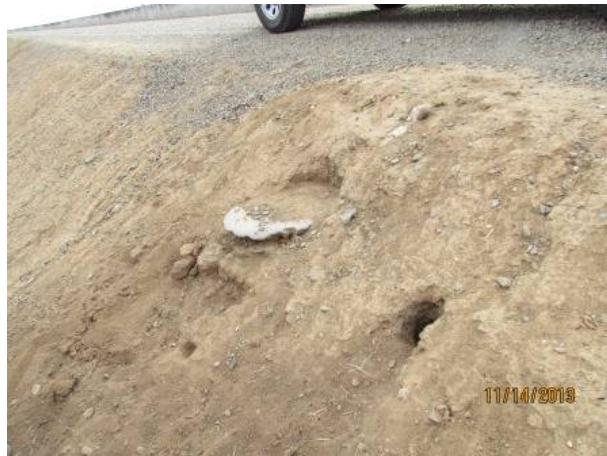
Levee Mile Report Line	122
Start Levee Mile	15.73
End Levee Mile	15.73
Location	Land Side
Category	Earthen Levee
Item	Animal Control
An animal hole was found on the landside slope of the levee looking upstream.	
<i>pkazi_f_20131119_064.JPG</i>

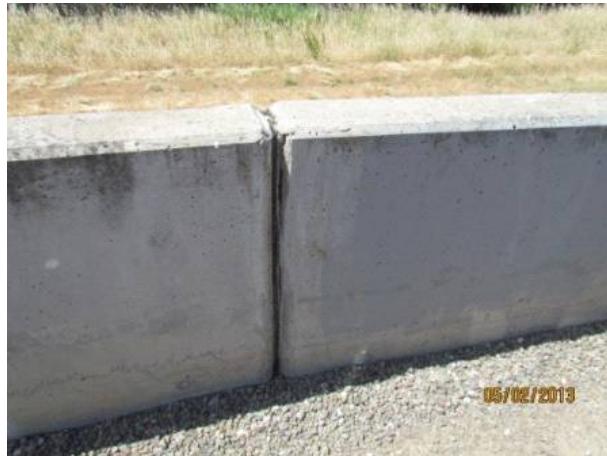
Levee Mile Report Line	124
Start Levee Mile	16.08
End Levee Mile	16.08
Location	Water Side
Category	Concrete Floodwalls
Item	Monolith Joints
The monolith joint material is deteriorating at the waterside shoulder of the levee looking downstream.	
<i>pkazi_f_20131001_314.JPG</i>

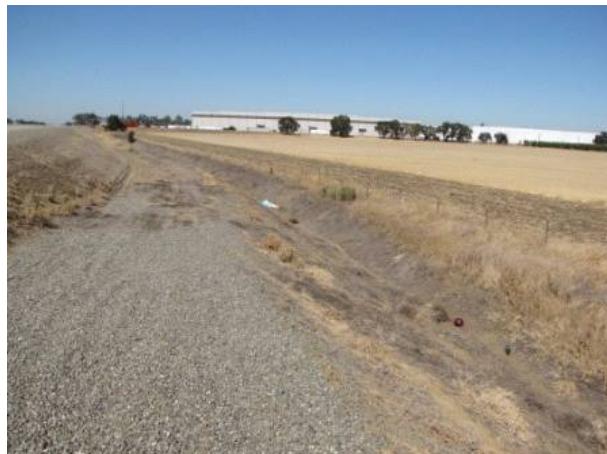
Levee Mile Report Line	125
Start Levee Mile	16.09
End Levee Mile	16.60
Location	Land Side
Category	Earthen Levee
Item	Encroachments
View of a ditch adjacent to the landward toe looking downstream.	
<i>pkazi_f_20131001_379.jpg</i>

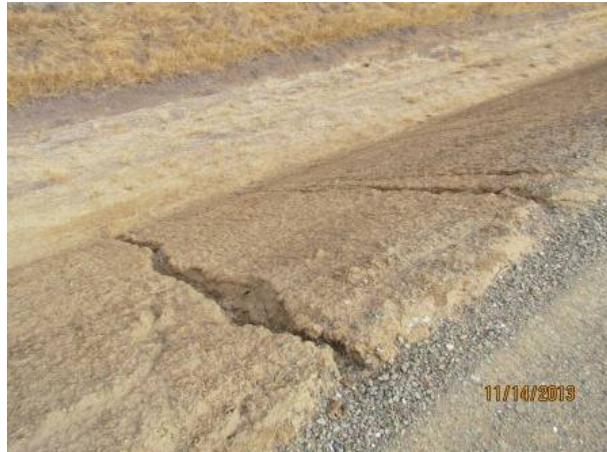
Levee Mile Report Line	126
Start Levee Mile	16.39
End Levee Mile	16.39
Location	Land Side
Category	Earthen Levee
Item	Erosion / Bank Caving
Erosion caused by runoff on the landside slope of the levee looking upstream.	
pkazi_f_20131119_065.JPG

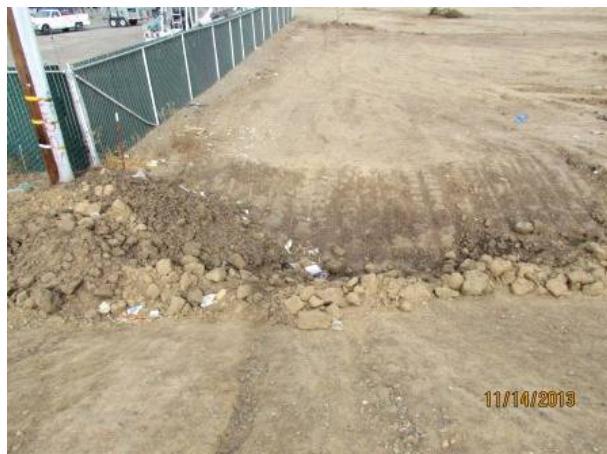
Levee Mile Report Line	128
Start Levee Mile	16.87
End Levee Mile	16.87
Location	Land Side
Category	Earthen Levee
Item	Slope Stability
Slope instability was found on the landside toe of the levee looking from the crown.	
pkazi_f_20131119_066.JPG

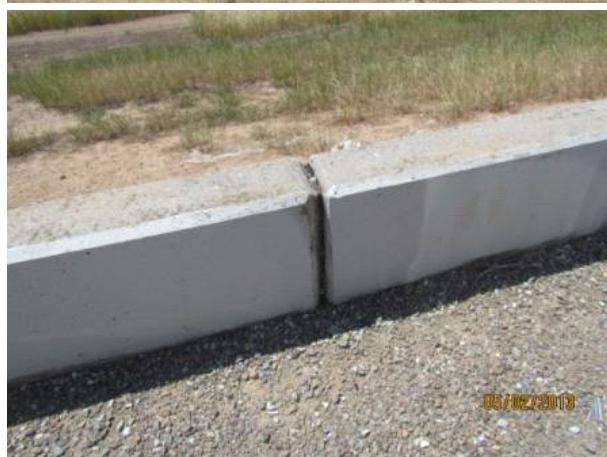
Levee Mile Report Line	129
Start Levee Mile	16.87
End Levee Mile	16.87
Location	Water Side
Category	Concrete Floodwalls
Item	Monolith Joints
The monolith joint material is deteriorating at the waterside shoulder of the levee looking downstream.	
pkazi_f_20131001_323.JPG

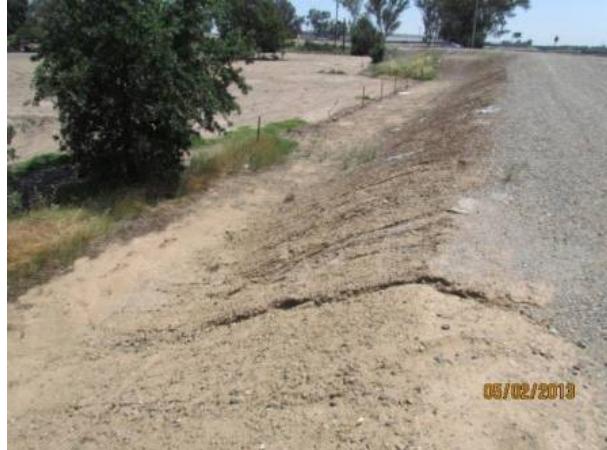
Levee Mile Report Line	130
Start Levee Mile	16.87
End Levee Mile	16.87
Location	Land Side
Category	Earthen Levee
Item	Erosion / Bank Caving
Slope Instability was found on the landside slope of the levee looking upstream.	
pkazi_f_20131001_320.JPG

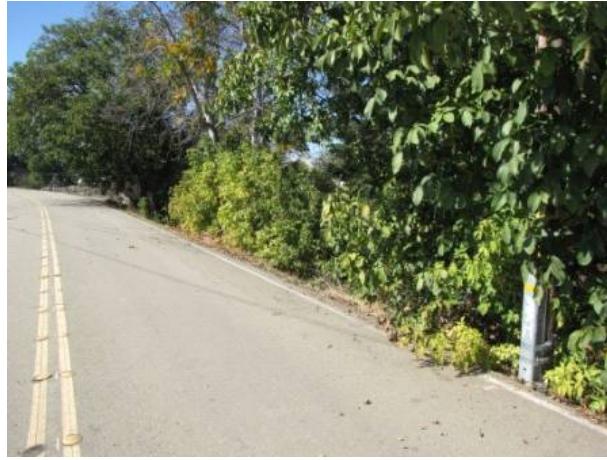
Levee Mile Report Line	136
Start Levee Mile	18.54
End Levee Mile	18.55
Location	Land Side
Category	Earthen Levee
Item	Vegetation
View of landowner planted and maintained vegetation along the landward slope looking downstream.	
pkazi_f_20131001_382.jpg

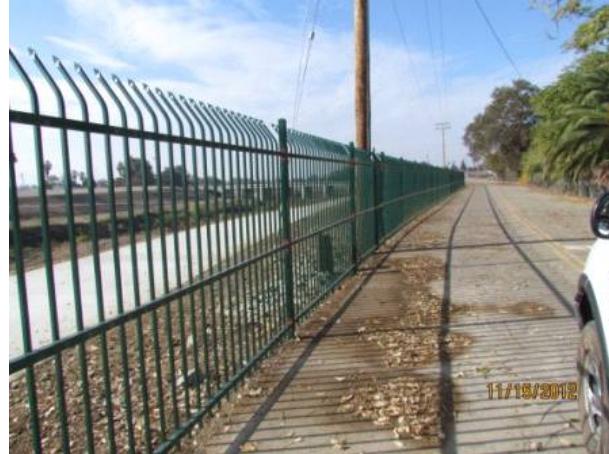
Levee Mile Report Line	138
Start Levee Mile	19.80
End Levee Mile	19.92
Location	Water Side
Category	Earthen Levee
Item	Encroachments
A fence was placed by the City of Stockton on the waterside shoulder of the levee looking downstream.	pkazi_f_20131001_334.jpg

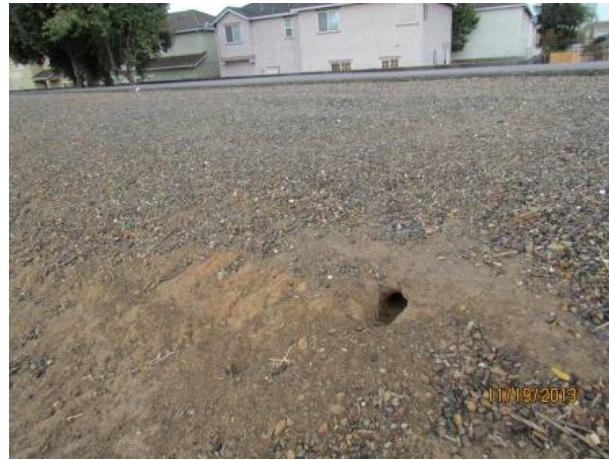
Levee Mile Report Line	140
Start Levee Mile	20.12
End Levee Mile	20.12
Location	Water Side
Category	Earthen Levee
Item	Animal Control
A rodent hole was found on the waterside slope of the levee looking downstream.	pkazi_f_20131119_067.JPG

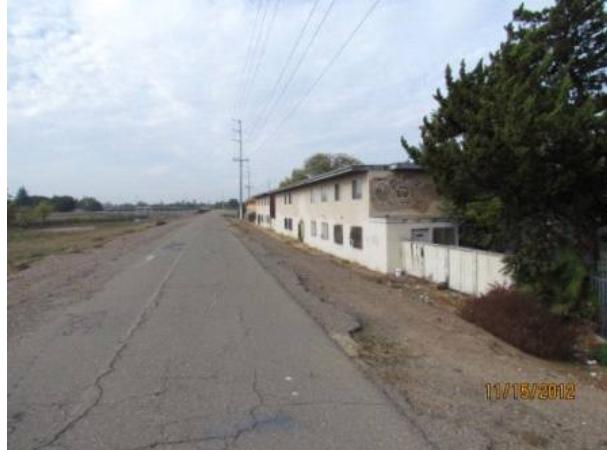
Levee Mile Report Line	145
Start Levee Mile	20.91
End Levee Mile	21.01
Location	Land Side
Category	Earthen Levee
Item	Encroachments
View of the buildings on the landside of the levee looking downstream.	
<i>pkazi_f_20131001_294.jpg</i>

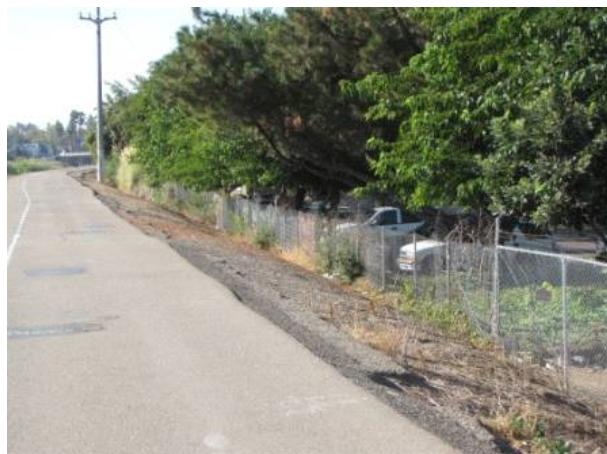
Levee Mile Report Line	149
Start Levee Mile	21.46
End Levee Mile	21.61
Location	Land Side
Category	Earthen Levee
Item	Encroachments
View of fence along the landward toe looking downstream.	
<i>pkazi_f_20131001_384.jpg</i>

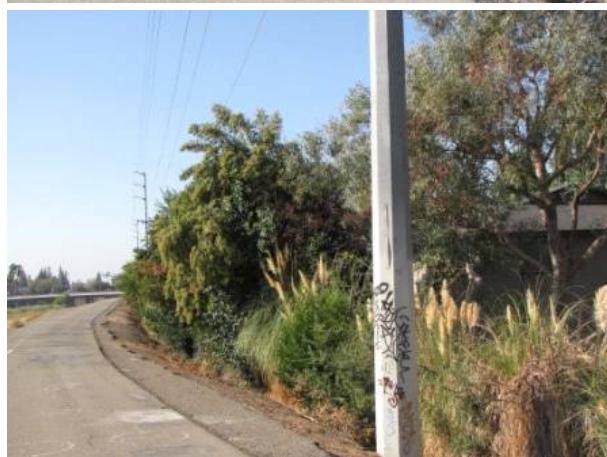
Levee Mile Report Line	150
Start Levee Mile	21.52
End Levee Mile	21.73
Location	Land Side
Category	Earthen Levee
Item	Vegetation
View of landscaping along the landward slope and toe looking downstream.	
<i>pkazi_f_20131001_296.jpg</i>

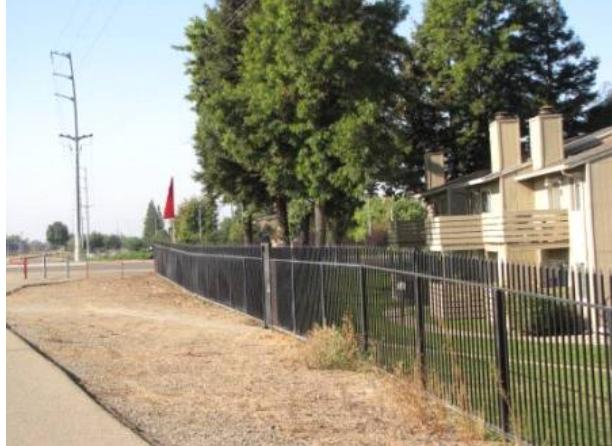
pkazi_f_20131001_385.jpg

Levee Mile Report Line	151
Start Levee Mile	21.73
End Levee Mile	21.77
Location	Land Side
Category	Earthen Levee
Item	Encroachments
View of fence along the landward shoulder looking downstream.

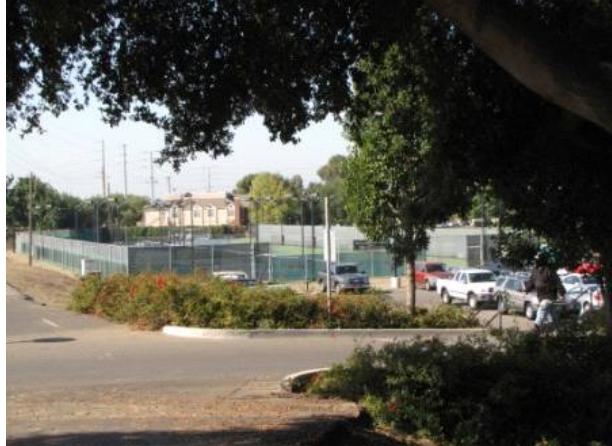
pkazi_f_20131001_386.jpg

Levee Mile Report Line	152
Start Levee Mile	22.11
End Levee Mile	22.11
Location	Land Side
Category	Earthen Levee
Item	Vegetation
View of landscaping maintained by UOP along the landward slope looking downstream.

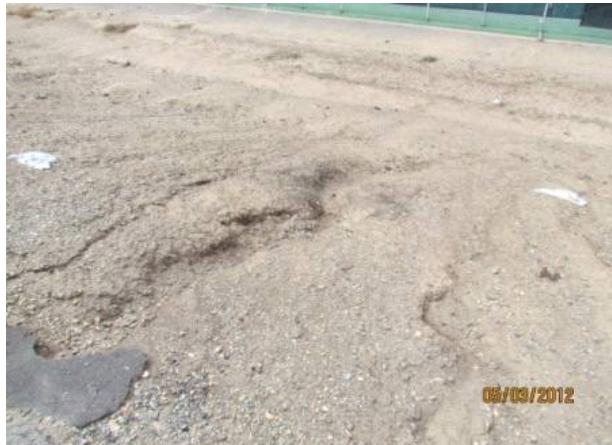
pkazi_f_20131001_361.jpg

Levee Mile Report Line	153
Start Levee Mile	22.17
End Levee Mile	22.17
Location	Land Side
Category	Earthen Levee
Item	Erosion / Bank Caving
Erosion was found due to runoff on the landside of the levee looking downstream.

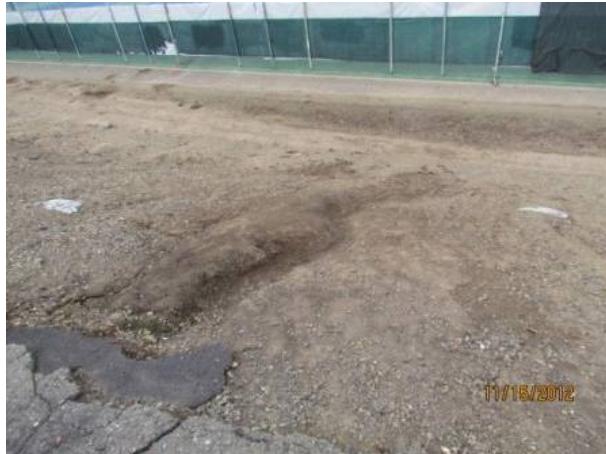
11/16/2012

Levee Mile Report Line	153
Start Levee Mile	22.17
End Levee Mile	22.17
Location	Land Side
Category	Earthen Levee
Item	Erosion / Bank Caving
Updated picture of the erosion located on the landside of the levee looking downstream.	
pkazi_f_20131001_362.jpg

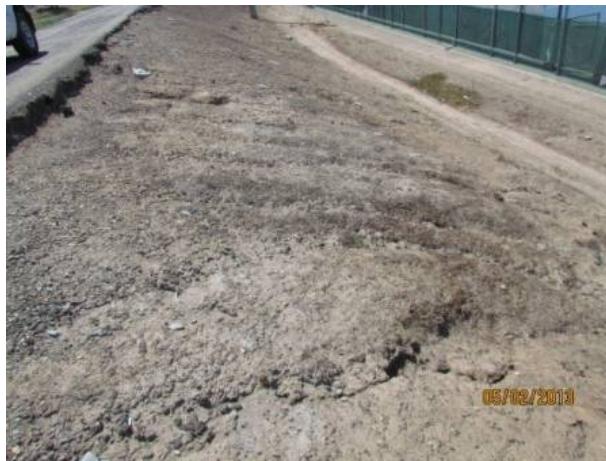
05/02/2013

Levee Mile Report Line	153
Start Levee Mile	22.17
End Levee Mile	22.17
Location	Land Side
Category	Earthen Levee
Item	Erosion / Bank Caving
Updated picture of the erosion caused by run off on the landside slope of the levee looking downstream during spring 2013 inspection.	
pkazi_f_20131001_363.JPG

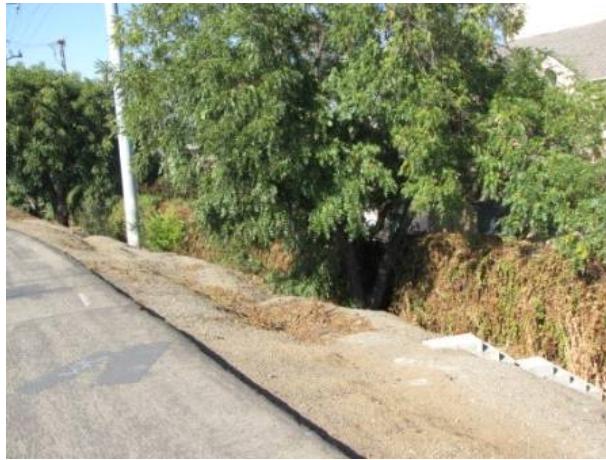
Levee Mile Report Line	154
Start Levee Mile	22.27
End Levee Mile	22.32
Location	Land Side
Category	Earthen Levee
Item	Vegetation
View of landscaping along the landward toe of the levee looking downstream.	
pkazi_f_20131001_297.jpg

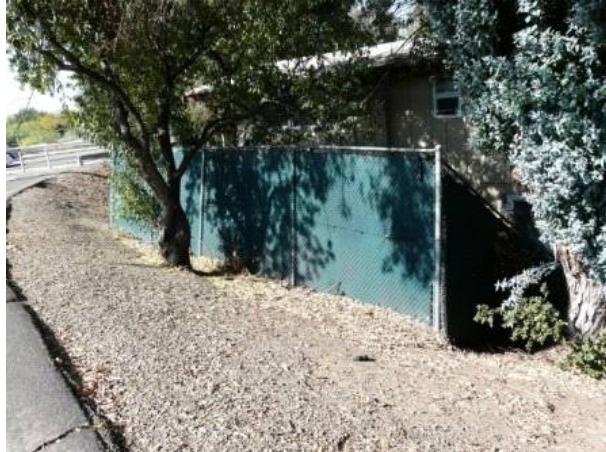
Levee Mile Report Line	155
Start Levee Mile	22.36
End Levee Mile	22.37
Location	Land Side
Category	Earthen Levee
Item	Encroachments
Fence located from LM 22.36 to LM 22.37 significantly encroaches onto landside levee slope.	pkazi_f_20131001_324.JPG

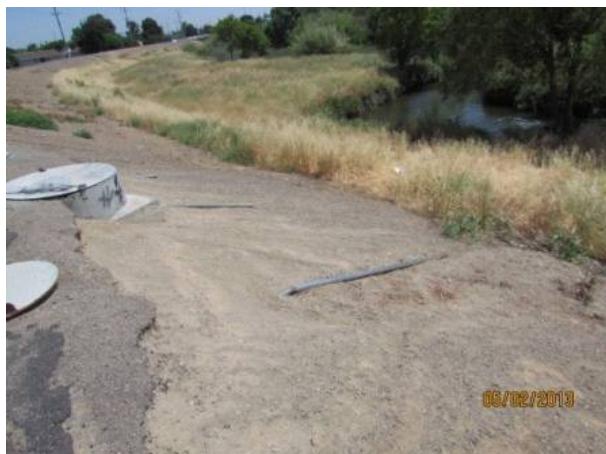
Levee Mile Report Line	156
Start Levee Mile	22.59
End Levee Mile	22.59
Location	Water Side
Category	Earthen Levee
Item	Encroachments
View of the exposed pipe causing erosion on the waterside slope of the levee looking upstream.	pkazi_f_20131001_342.JPG

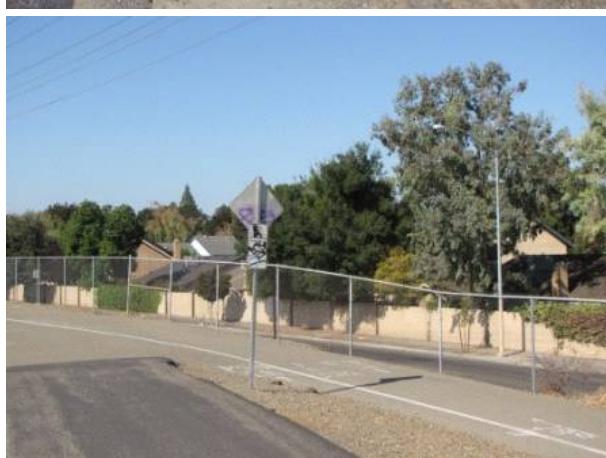
Levee Mile Report Line	157
Start Levee Mile	22.88
End Levee Mile	22.90
Location	Land Side
Category	Earthen Levee
Item	Encroachments
View of a fence along the landward shoulder looking downstream.	pkazi_f_20131001_387.jpg
